Structural Engineers Association of Kansas and Missouri Report

“Investigations and Recommendations
based on the May 22, 2011
Joplin, Missouri Tornado”

May 2012

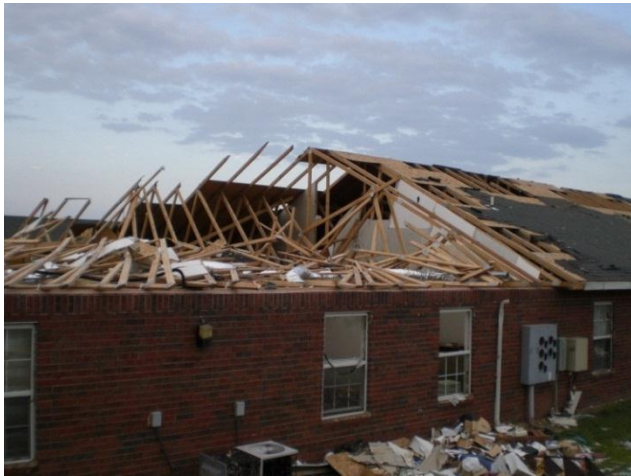
Photo 1: Note the anchorage of the trusses to the sidewalls in this building: the top chord of the truss broke before the anchorage failed.

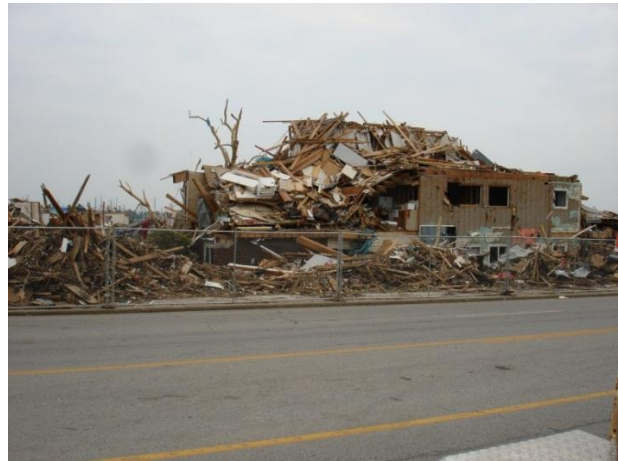
Photo 2: Destruction of the main roof system, second story, but the redundancy of the wood structure prevents total collapse.

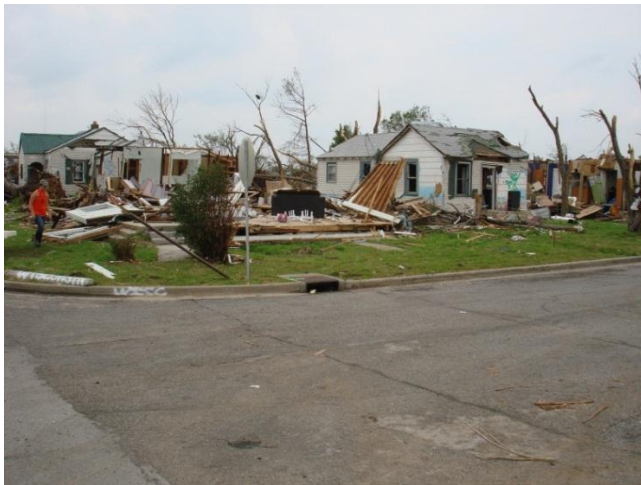
Photo 3: Corner house destroyed, while adjacent homes remain intact.

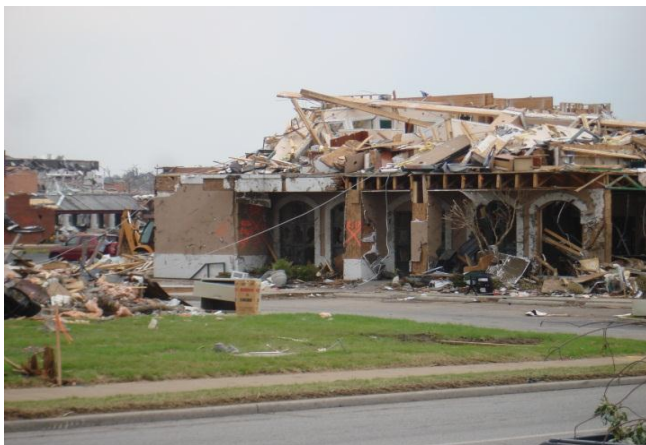
Photo 5: Non-residential building remains standing despite major damage.

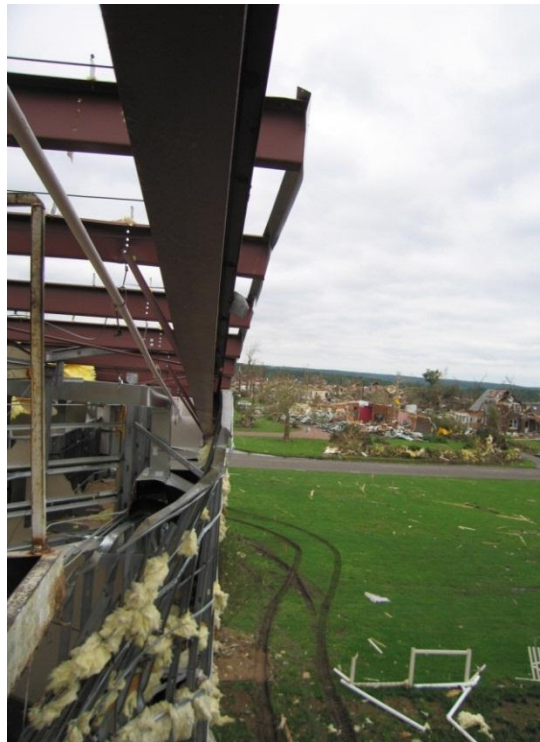
1. The tall stud walls at the east and west ends of the sanctuary failed under direct wind load. The studs and top track were pulled clear of the supporting rigid frame and collapsed inward. There are some questions regarding the actual connections of the metal studs to the track, but actual drawings were not available to verify the required attachment and compare to the actual conditions.

Photo 8: Cold Formed Metal Stud Failure due to poor attachment to the underside of the purlin overhang.

2. The large wall at the east side of the sanctuary was not supplied by PEMB manufacturer and may or may not have been competently engineered. Connection failure at the top of this wall appears to have led to its failure. Even though the studs may have been properly sized, it appears that insufficient consideration was given to the upper connection details.

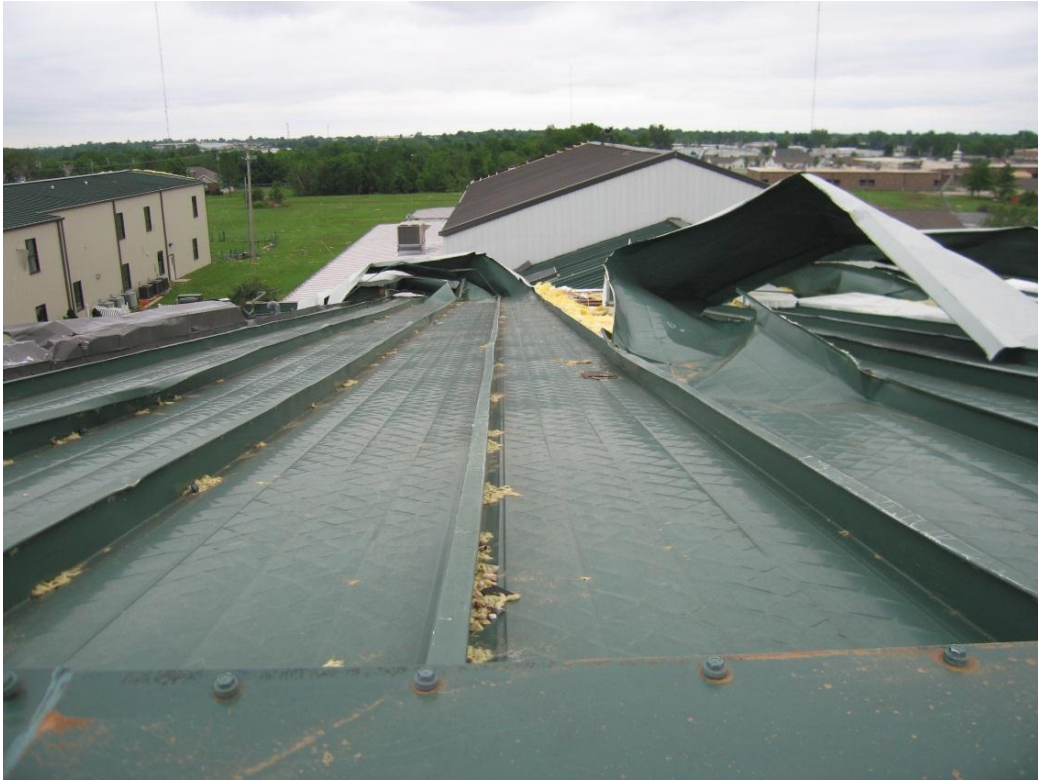
3. The standing seam metal roof was blown upward and away from the eaves and east end wall of the structure. There is no evidence of clip failure; instead it appears that the applied batten strip at the panel edges failed, allowing the panel to pull away from the clips.

Photo 9: Roof Damage to north slope of sanctuary.

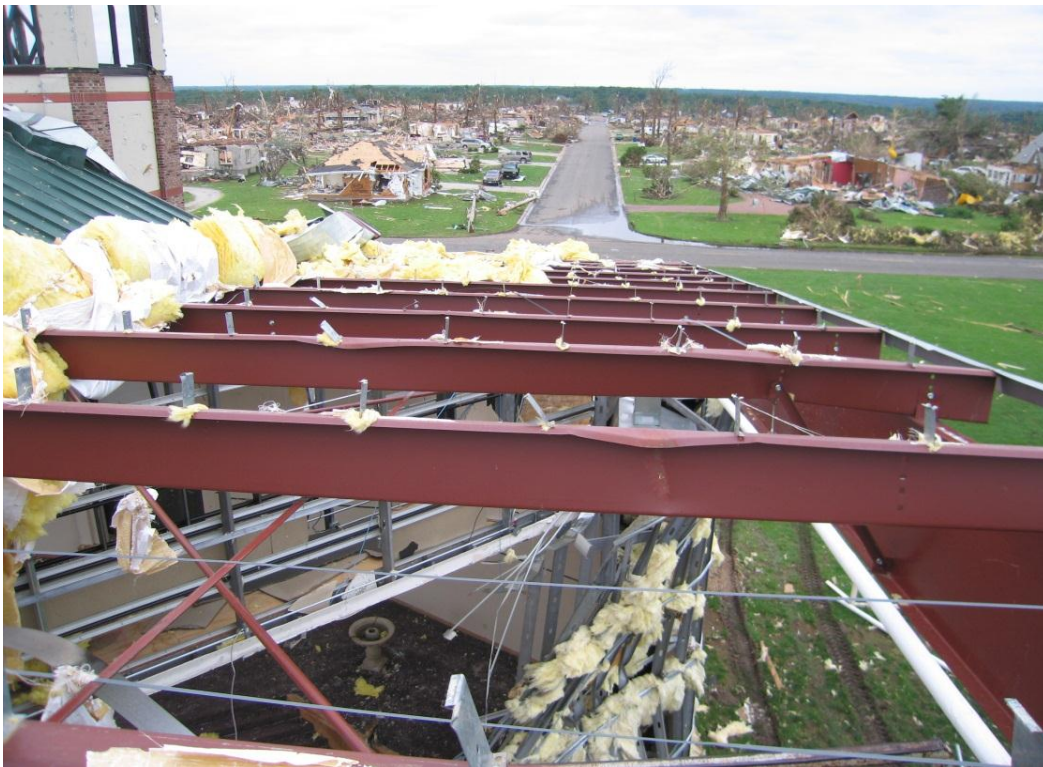
2. Diagonal kicker braces from the wall studs to the purlins caused local buckling in the cold formed steel Z-section purlins. Some purlins were twisted and rolled over by the uplift forces.

Photo 10: Purlin damage at the east end of the sanctuary building, along with failure of the exterior wall framing.

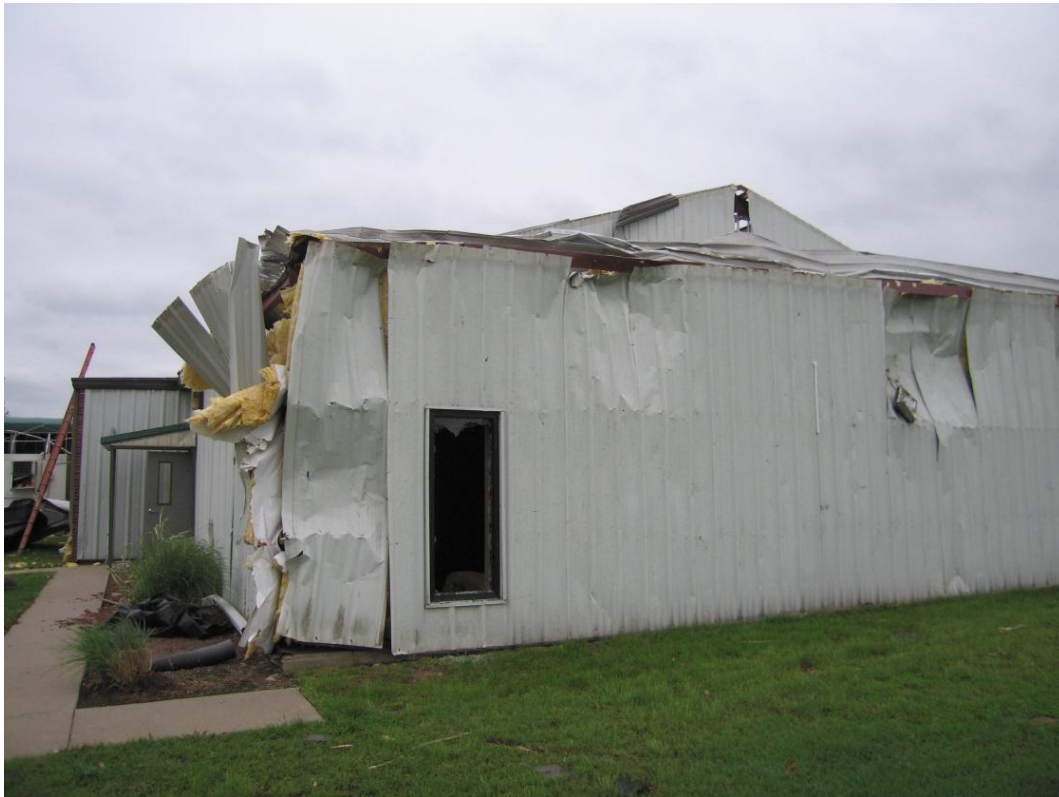
Photo 11: Damage to northeast corner of building.

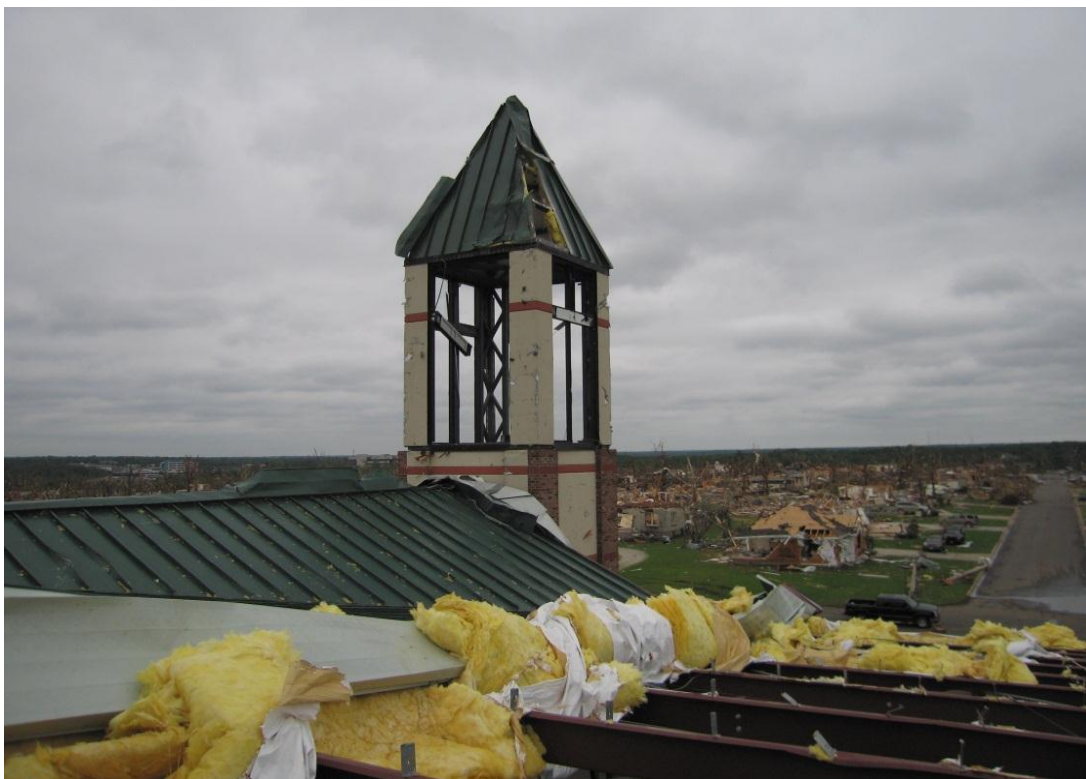
8. Immediately to the south of the main sanctuary is an independent steeple structure, which is framed with a braced tube structure. This was clad with composite panels on the walls and an SSMR that matched that of the sanctuary. The cladding of the steeple sustained heavy damage or was completely blown off. There appeared to be no damage to the primary structure of the steeple.

Photo 12: The free standing church steeple exhibiting the loss of cladding, while the main structure system remains intact.

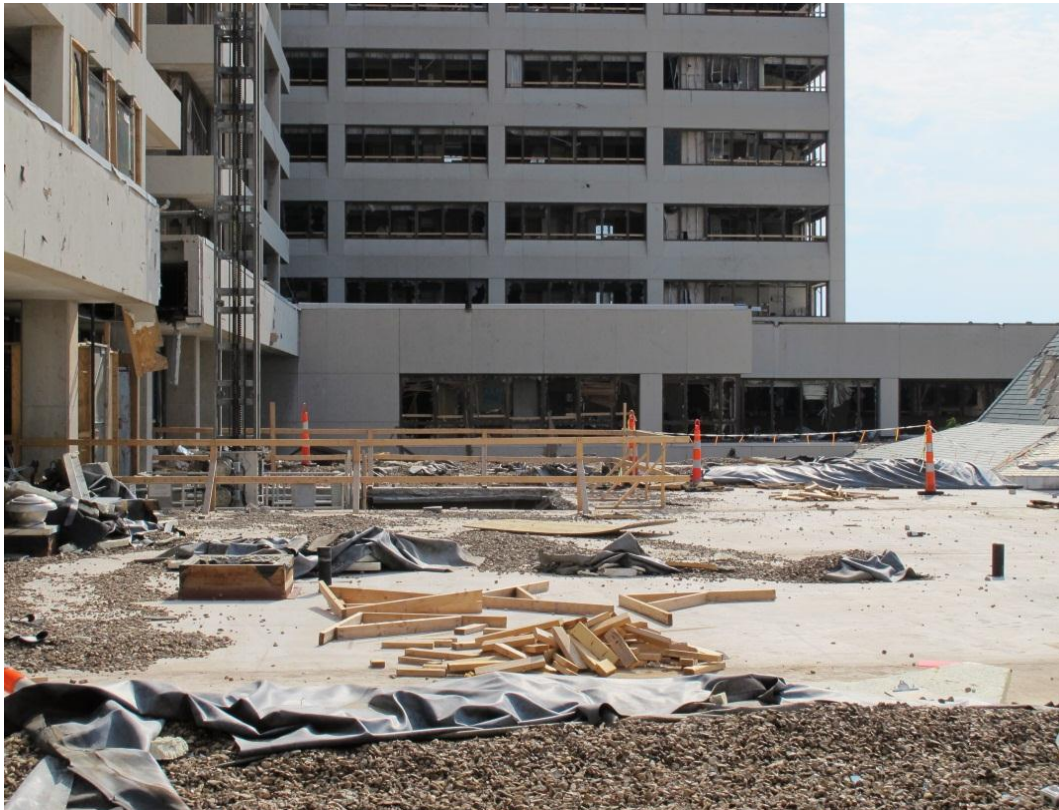
3. The exterior cladding for the structural steel framed buildings consists of EIFS on light gage metal stud attached to horizontal structural steel framing. As can be seen in **Photo 13**, the tornado damage includes broken glazing and impact damage to the EIFS. Once the winds penetrated the glazing, additional damage occurred to interior finishes and partitions as shown in **Photo 14**.

Photo 13: Concrete-frame building at left, steel frame building beyond.

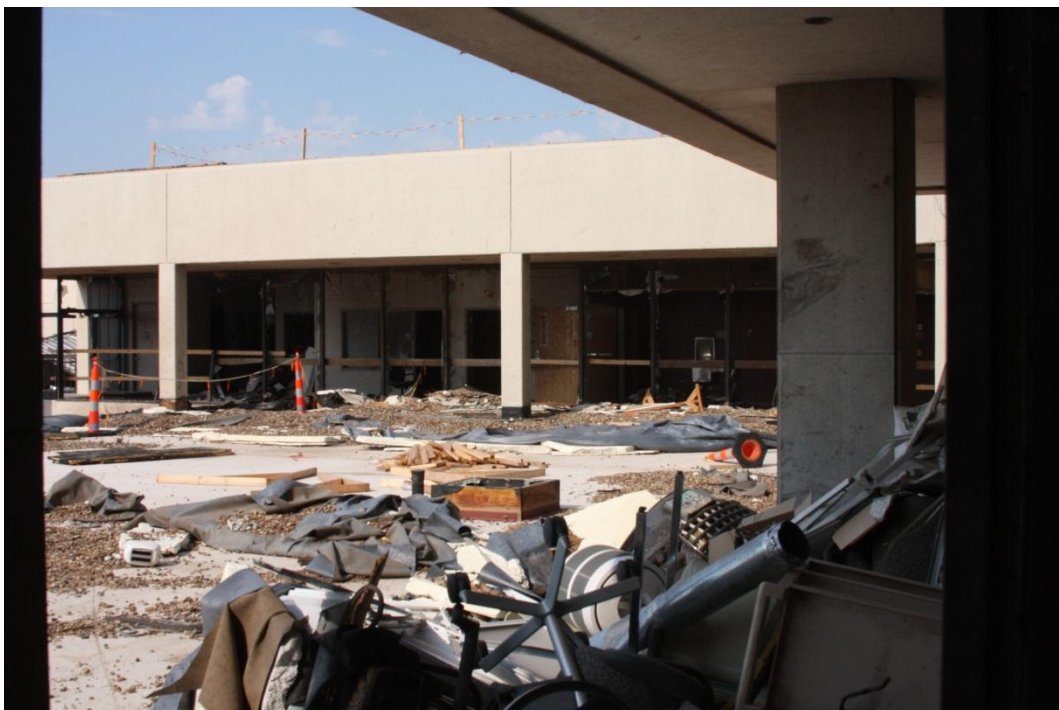
Photo 14: St. John's Medical Hospital damage, note the ballasted roof, light weight concrete on roof and curtain wall glazing system destruction.

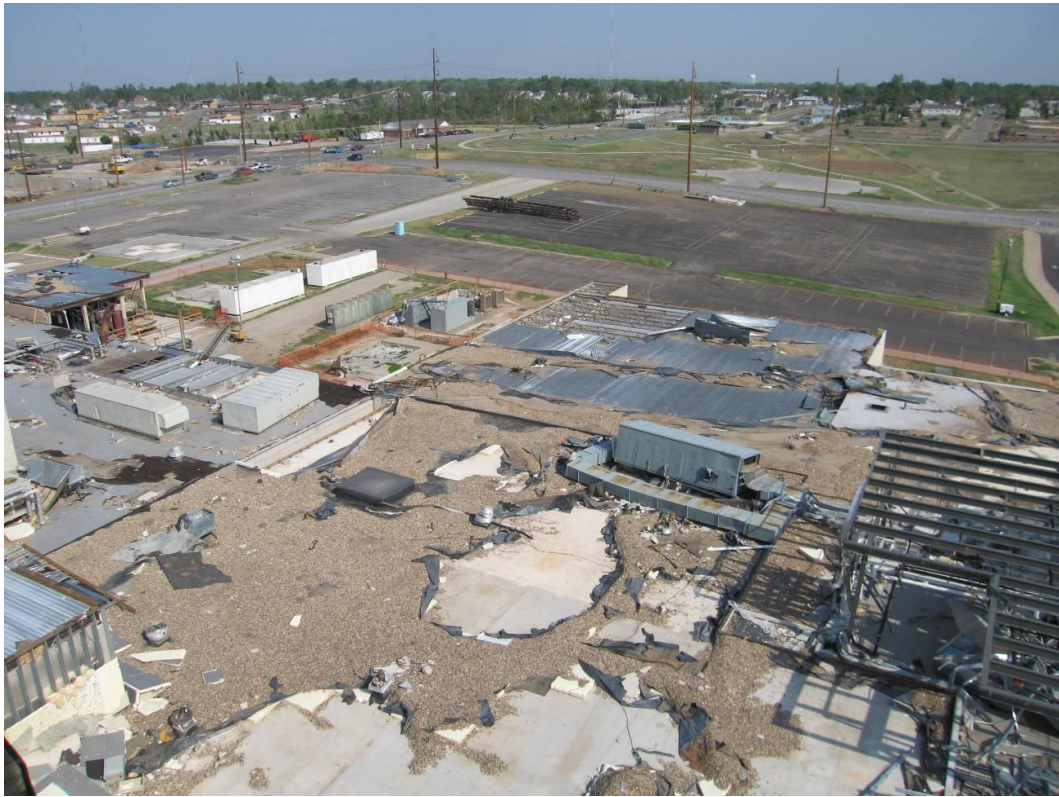
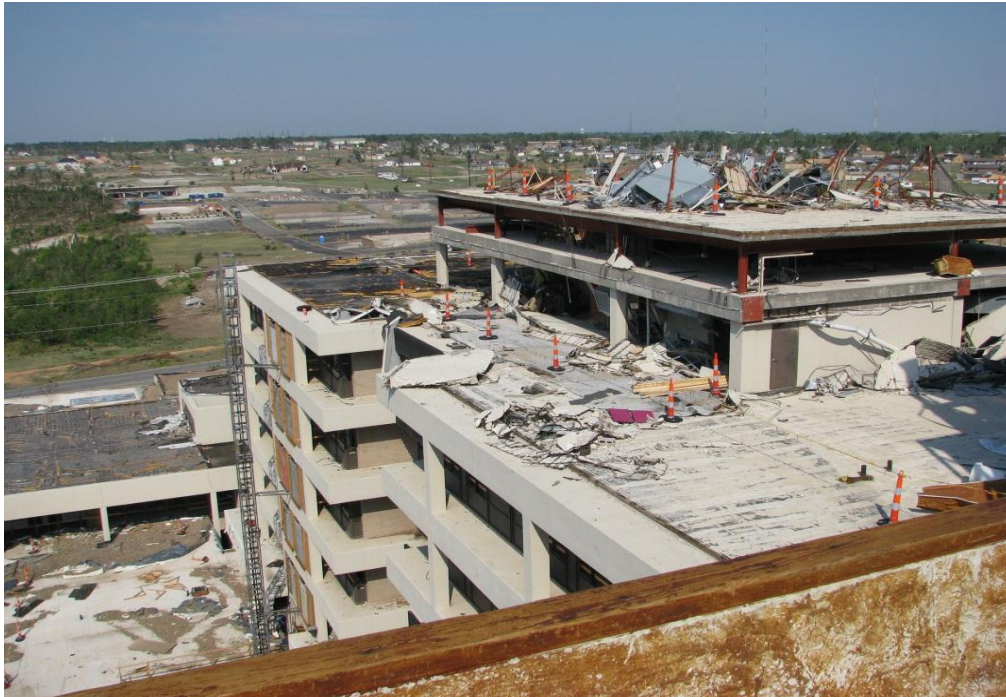
5. The reinforced concrete frame hospital building was similarly damaged regarding glazing and roof membrane. The inset curtain wall/glazing system remained largely in place. The steel or concrete framed mechanical penthouses located on the roof of the buildings suffered the worst damage with completely or partially stripped wall and roof cladding as shown in **Photos 15 and 16**.

Photo 15: St. John's Medical Center, damage to penthouses and roof equipment. Note the missing metal roof deck on penthouse, looking NW.

Photo 16: St. John's Medical Center, penthouse at concrete frame building with mechanical penthouse constructed of structural steel and light weight concrete on metal roof deck.

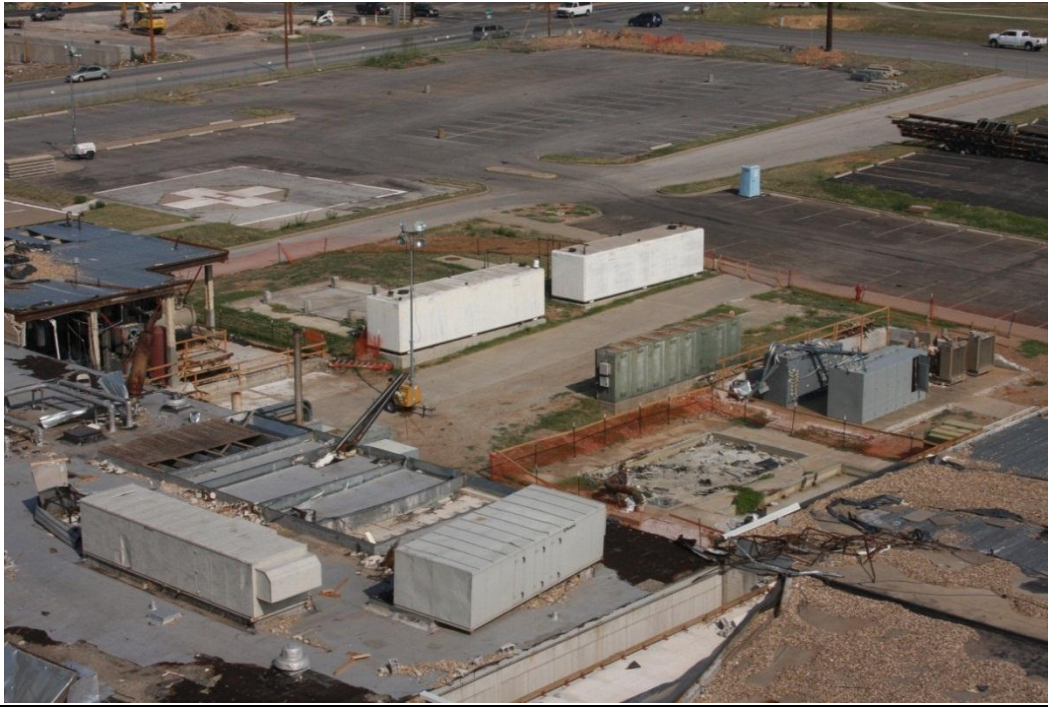
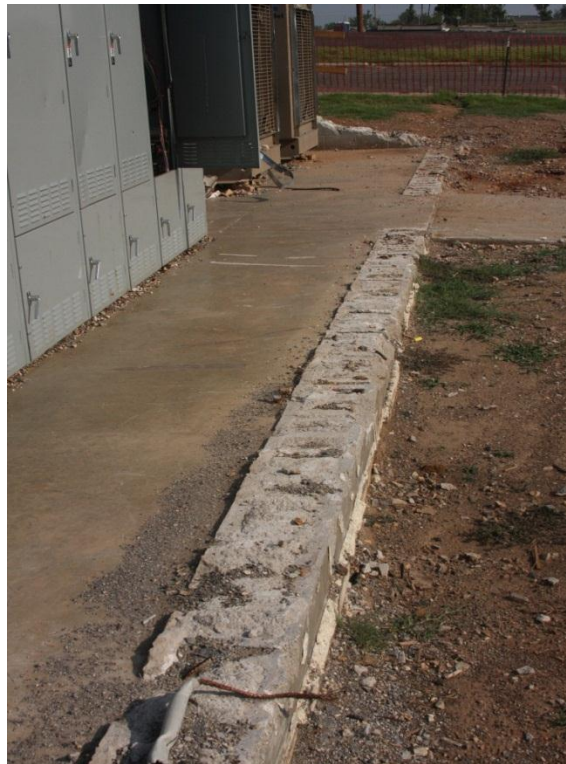
6. The mechanical and electrical buildings of the hospital were severely damaged by the tornado and the debris from the tornado impacting the walls. The investigating team arrived after the clean-up of the area, but did note that for the twelve inch concrete masonry unit (CMU) walls surrounding the generator room were removed because of significant damage. The wall appeared to be reinforced with one number four bar at forty-eight inches on center and fully grouted below grade. The mechanical room area constructed in a similar manner with CMU walls and a veneer was reinforced very sporadically along the length of the wall. The actual spacing of the reinforcement was not determined. Drawings of the area were not available to investigate further, reference **Photos 17 and 18**.

Photo 17: St. John's Medical Center – mechanical and back-up generator buildings destroyed by the tornado. Area cleaned prior to site visit.

Photo 18: St. John's Medical Center – The mechanical and back-up generator masonry wall buildings appear to lack sufficient reinforcing bars. Note: the area had been cleaned up prior to our investigation.

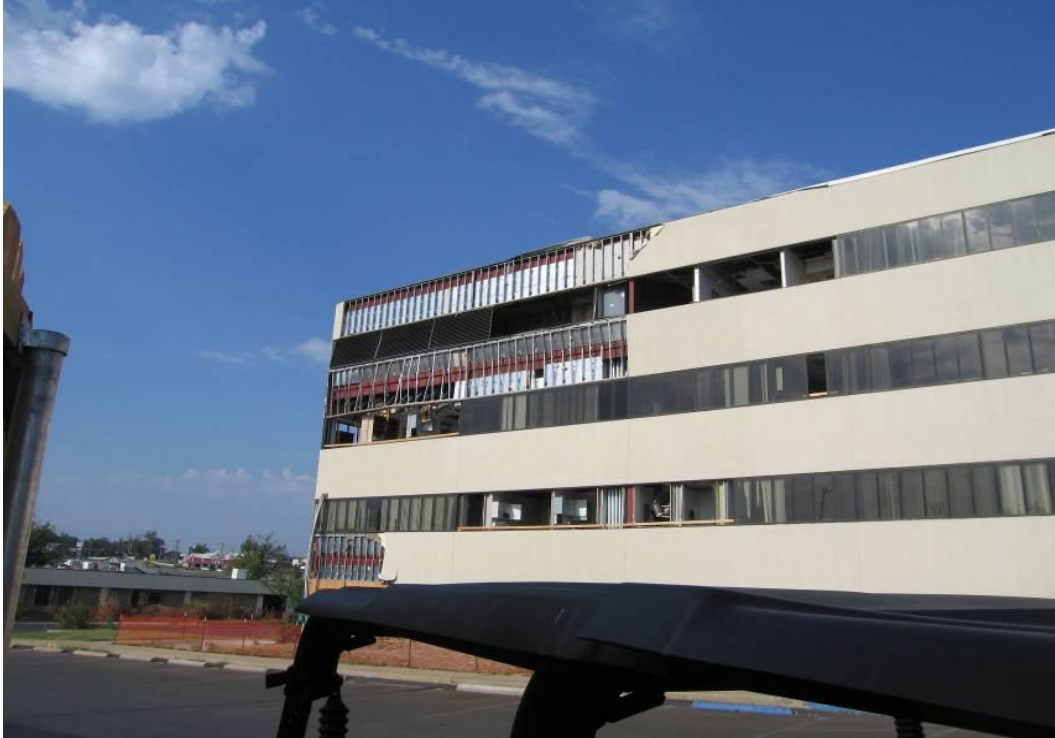
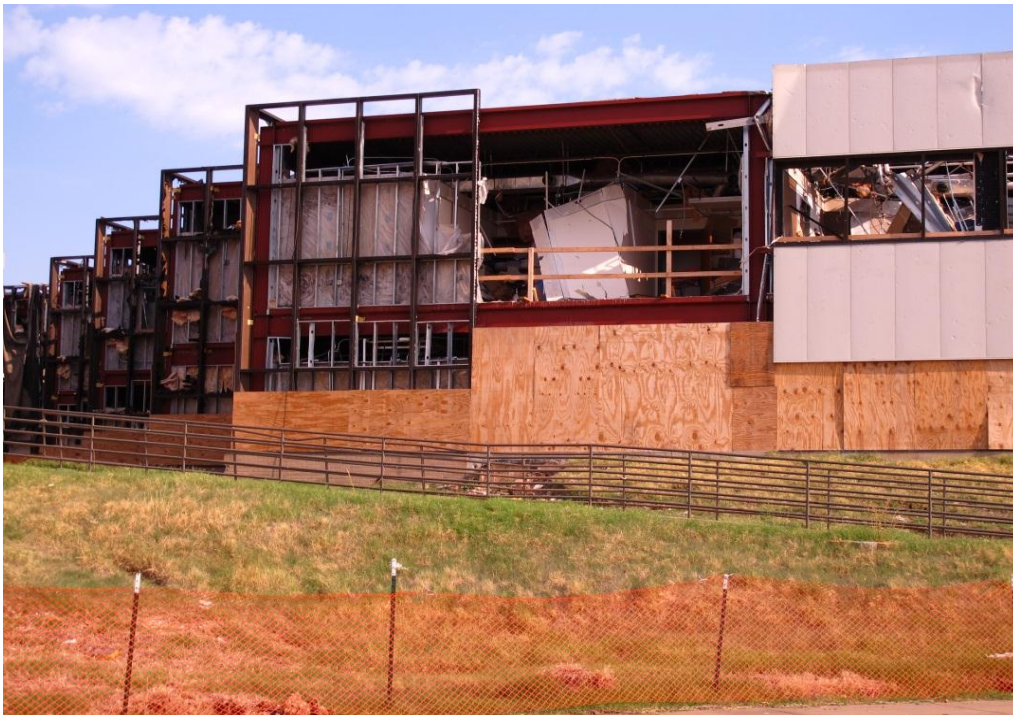
The wall cladding performed poorly on these buildings, although the general construction of them was similar to that of the main hospital buildings. Whether their location to the south of the main buildings played a role in the severity of the damage is not known. Examples of wall cladding damage are shown in **Photos 19 and 20**.

Photo 19: St. John's Medical Center - Steel Frame Building - damaged glazing and exterior cladding

Photo 20: St. John's Medical Center – Steel Frame MOB - damaged glazing and cladding

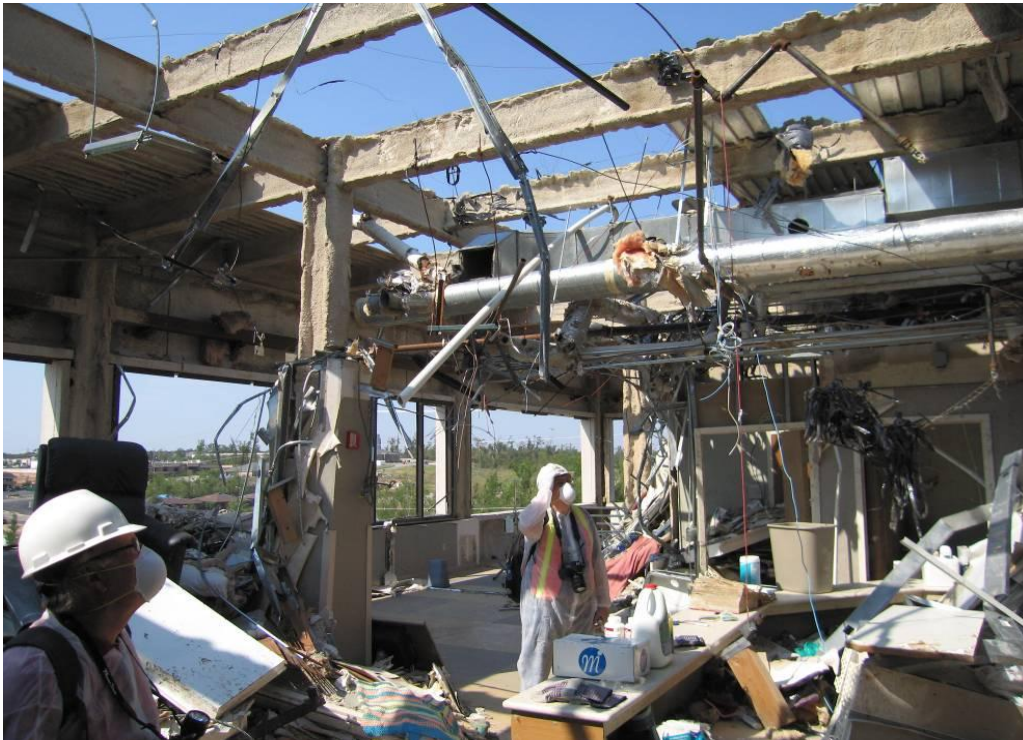
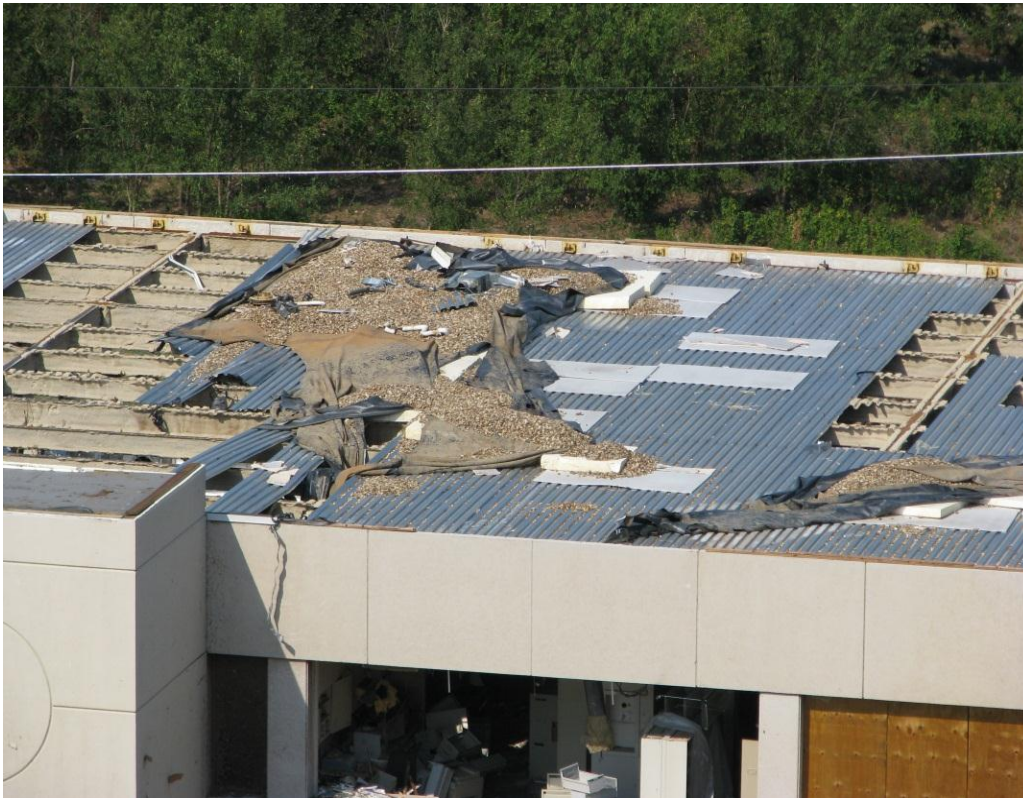
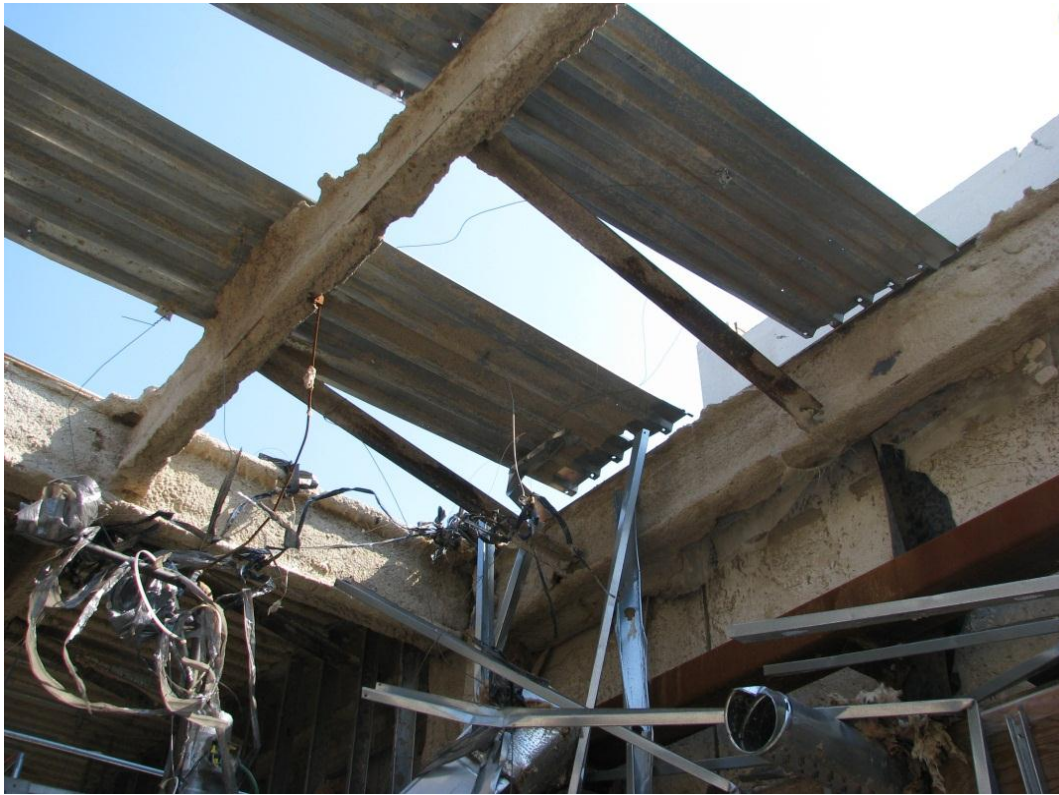
9. Unlike the main hospital buildings, the roofs of the other buildings performed poorly, with most buildings losing some, but not all of their roof decking. In all of the cases observed, the decking had been attached to the supporting members by an arc spot welds (puddle welds). These connections appeared to have failed, allowing the decking to be removed by the high winds. These failures were generally in the deck metal adjacent to the welds. Examples of these failures are shown in **Photos 21 through 23**.

Photo 21: St. John's Medical Center MOB - Steel Frame Building with missing and damaged ballasted metal roof decking.

Photo 22: St. John's Medical Center MOB - Steel Frame Building with missing and damaged ballasted metal roof decking.

Photo 23: St. John's Medical Center –Failed metal roof deck to structure connection.

2. Steel structures that rely strictly on a metal deck to provide diaphragm action at the roof level should be reviewed by the governing code agencies and design entities to consider the development of a more robust design methodology for these connections to the structural steel. The failure of these connections appear to significantly contribute to the instability of the overall structure, leading to possible proportional progressive collapse, not only in steel frame buildings, but in other building types, such as hard wall structures.

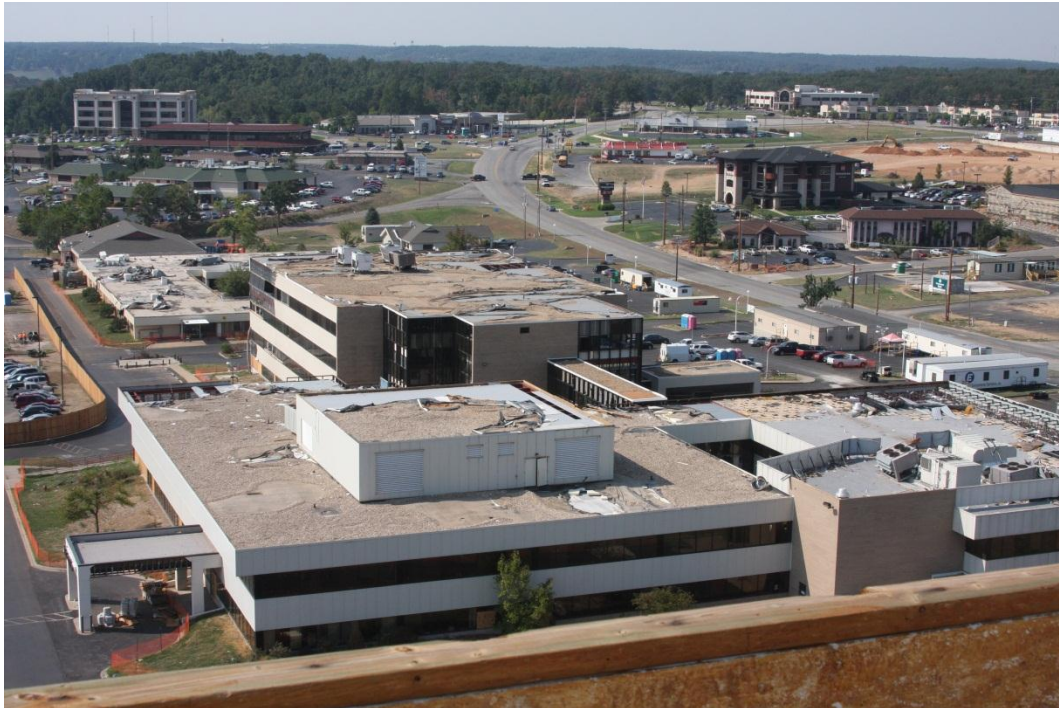
Photo 24: St. John's Medical Center MOB - Steel Frame Buildings with missing and damaged ballasted metal roof decking.

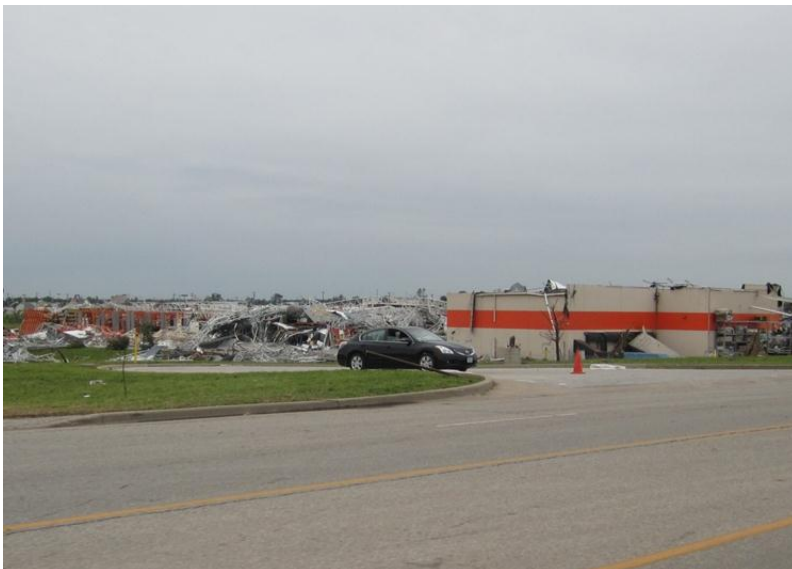
Photo 25: This is one example of a hard wall building system struck by the Joplin Tornado. It is noted that some walls remained standing due to a true cantilever condition of the tilt-up wall panels being support at their base and attached approximately four feet above, at a loading dock slab.

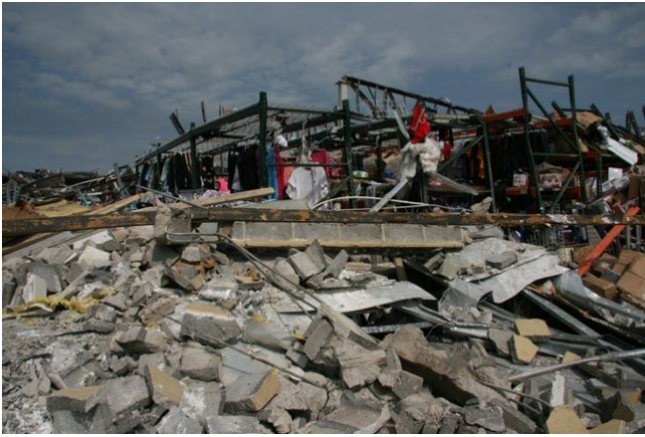
Photo 26: Roof level bond beam detached from top of CMU wall.

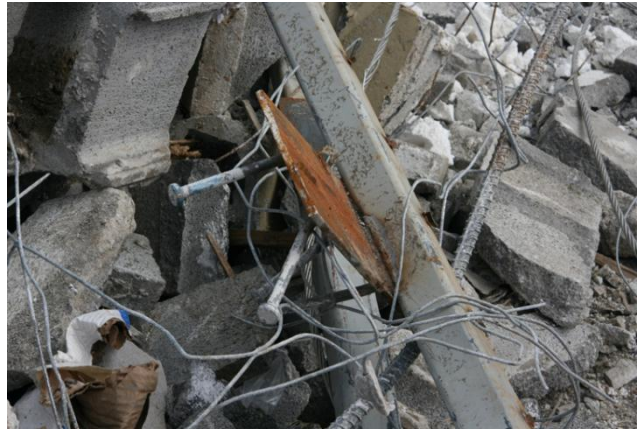
5. Steel embed plates with short studs pulled out of the top of the wall. It is uncertain if the failure was caused by wind or the resulting collapse and impact of the wall collapsing to the ground.

Photo 27: Embed plate with short studs pulled free from top of CMU wall.

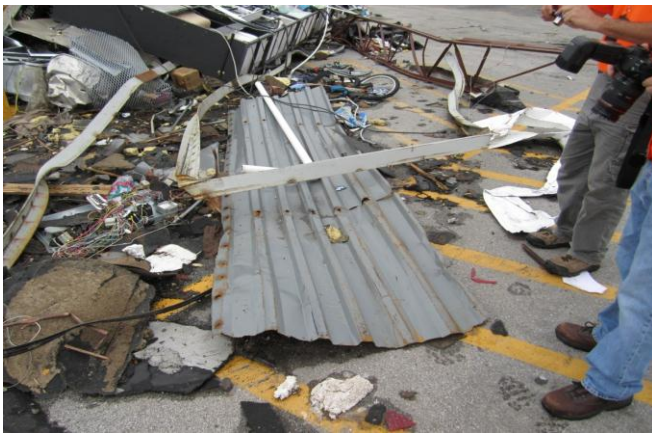
Photo 28: Metal deck detached from roof joists. Deck blown clear from building footprint and resting in parking lot.

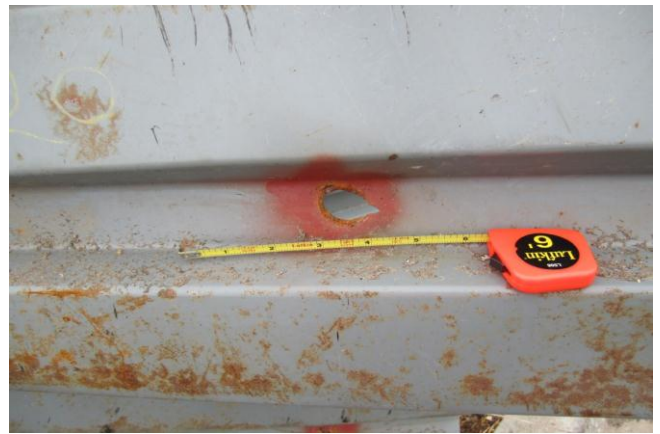
Photo 29: Failure of metal deck connection to joist top chord.

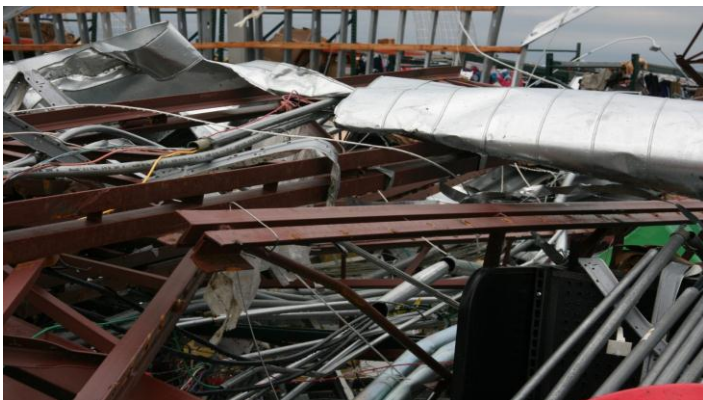
Photo 30: Arc spot welds on top of steel joist where metal deck pulled free. Failed weld at joist bearing with distorted clip angle. Joist remained inside the building footprint.

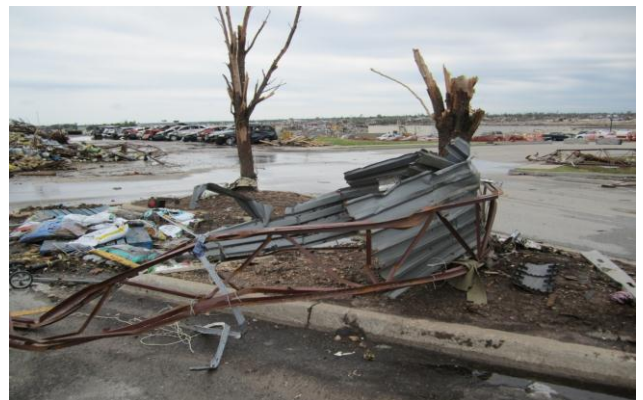
Photo 31: Both metal deck and steel joist blown clear from building footprint.

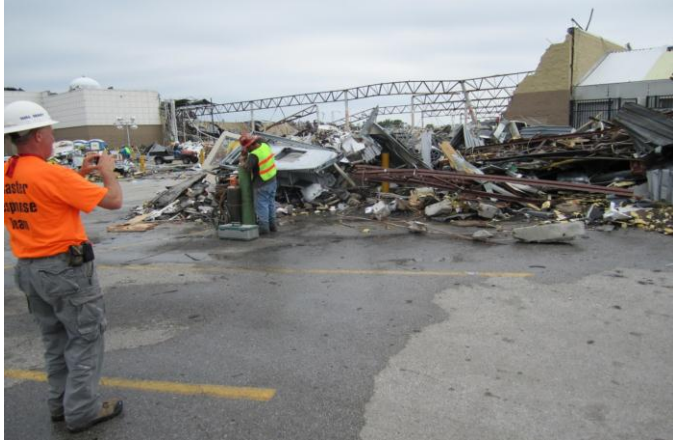
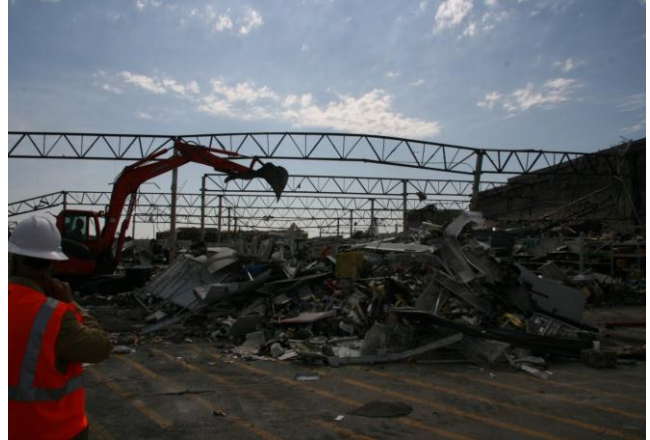
Photo 32: Upward bow of joist girder due to overstress loading of uplift pressures during tornado.

Photo 33: Upward bow of joist girder due to overstress loading of uplift pressures during tornado.

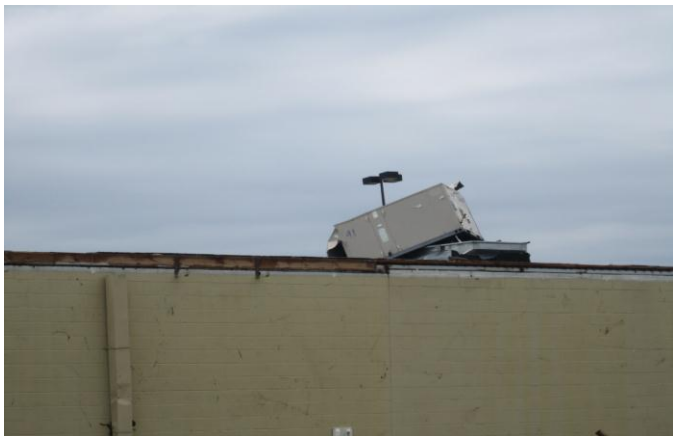
Photo 34: Architectural elements and mechanical units dislodged during high winds.

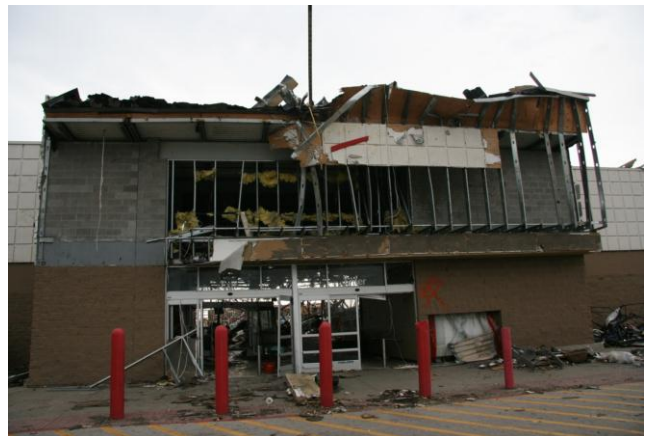
Photo 35: Architectural elements and cold formed steel stud framing damage.

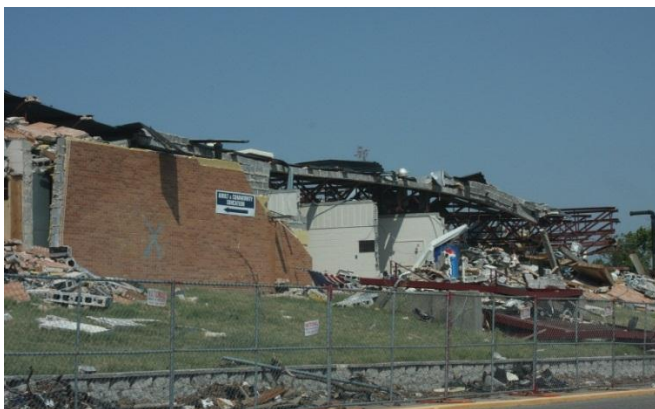
Photo 36: Hard wall collapse to the outside of building, with second level roof collapse.

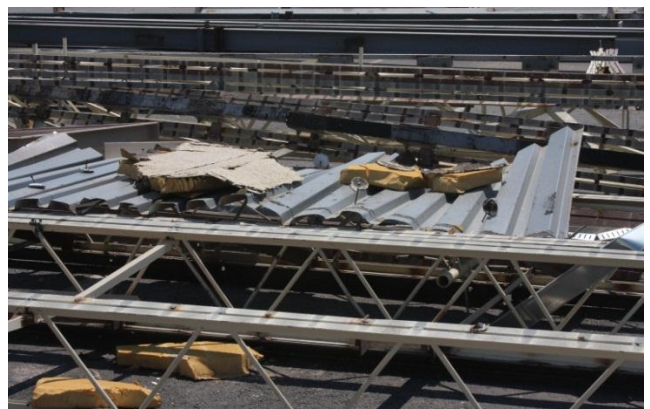
Photo 37: 18 gage metal deck attached to joist, after demolition of building struck by the tornado.
