Annual Conference
September 11-12, 2014
Columbus, Ohio

Lessons from Failures for Structural Engineers

David B. Peraza, PE
dperaza@exponent.com

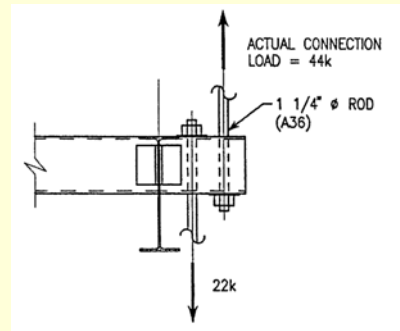
As-Built

- Using original detail, connection strength was 60% of that required by code
- The as-built detail doubled the load on the nut
- Quality and workmanship not an issue

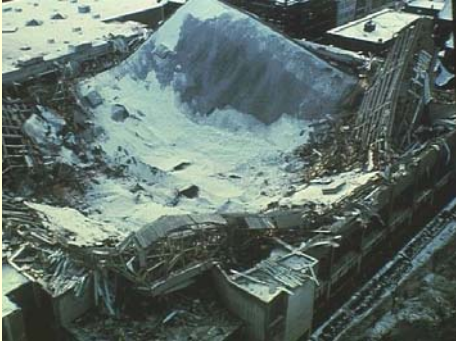
Five Years Later...Collapse

- Snow on roof was 15-18 psf ¹
- Largest load roof had experienced
- Design based on full braces at midpoints
- Actual ultimate live load capacity was 15-20 psf ²
- Actual dead load was 21% larger than design dead load (roofing, steel framing weight)

- Caused by Design error
 - Buckling (wrong unbraced length, soft braces)
 - Did not recognize bending

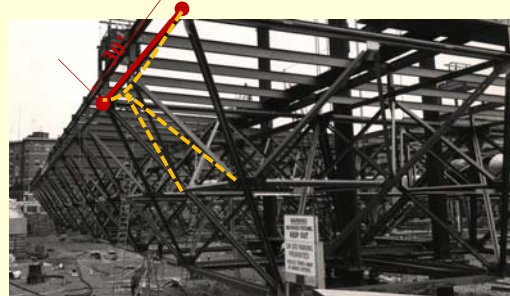
Reality

- Unbraced length 2X assumption
- Bending

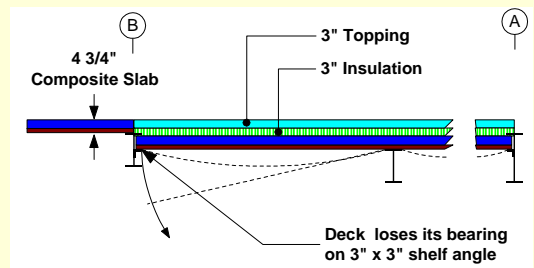
Collapse Mechanism

- Premature loading of uncured composite slab

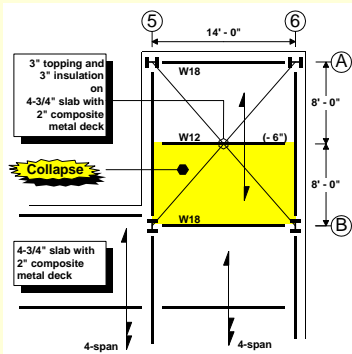
Collapse Area

- Buckled ribs at midspan
- Crease at intermediate beam
- “Half moon” puddle welds
- No sidelap connections
- Few side welds
- No puddle weld washers

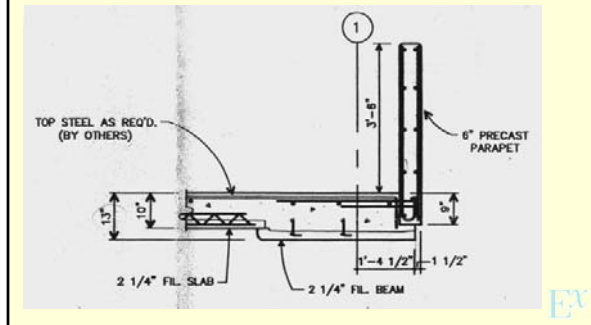
Revised Design—Spandrel Section

On Precast Shop Drawings (none on Engineer's drawings)

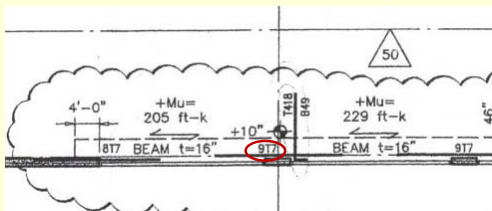
Design Drawings

- Beam bars shown next to column
- No section provided
- Top and bottom bars specified

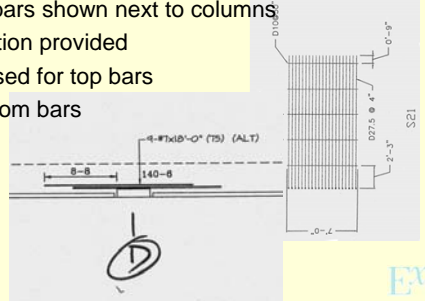
Rebar Shop Drawings

- Separate submittals
- Beam bars shown next to columns
- No section provided
- Mats used for top bars
- No bottom bars

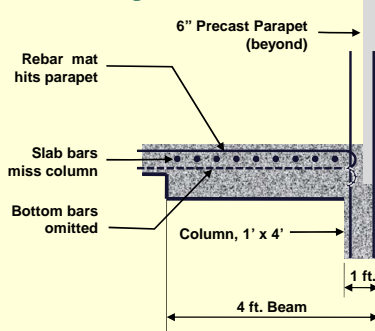
As-Built

(no bars through column)

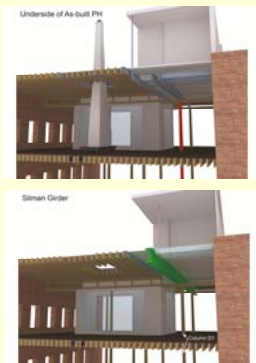
Column Overload

- **Potential Consequences**
 - Collapse of multiple levels
 - Sudden and catastrophic
- **Remedy**
 - Immediately restrict loading
 - Remove penthouse
 - Design new support system for penthouse that bypasses columns
