Annual Conference
September 11-12, 2014
Columbus, Ohio

Lessons from Failures for Structural Engineers

David B. Peraza, PE
dperaza@exponent.com

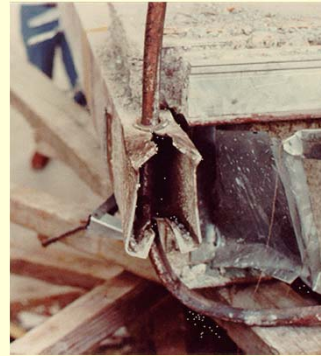
Typical 4th Floor Connection

- Using original detail, connection strength was 60% of that required by code
- The as-built detail doubled the load on the nut
- Quality and workmanship not an issue

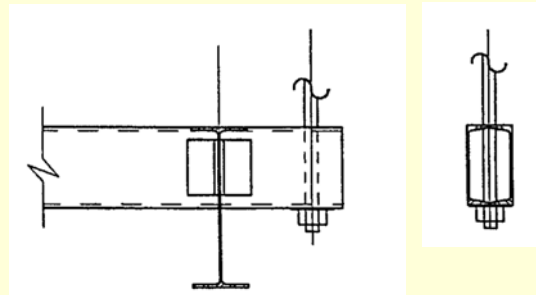
Engineer's Issued Drawing

- 26 week administrative trial (Missouri Licensing Board)
- "Failed to conform to acceptable engineering practice"
- Engineer was responsible for the change from one rod to two rods
- Engineer relied too much on steel contractor
- Engineers found guilty of gross negligence
- Licenses revoked for Gillum and Duncan

- Design of steel connections was delegated to steel fabricator's engineer
- The failed connection was not designed by anyone
- The detail on the structural drawings was conceptual
- Should have been retained to provide inspection

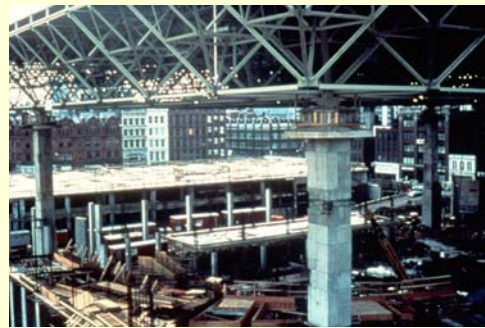
Final Position

- During assembly, the engineers were notified that the roof seemed to deflect excessively
- Bowing evident in photographs
- Siding contractor had difficulty installing at perimeter
- When in its final position, the engineers were told that the roof deflection was twice the computed values.
- A year after completion, a citizen notified the engineer that he observed an unsafe dip in the middle.

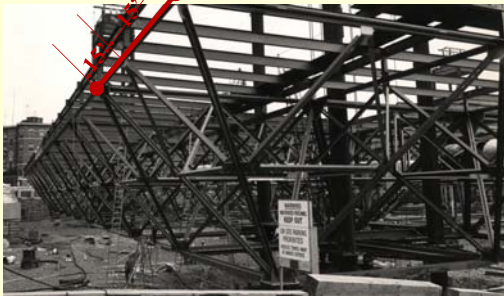
Assumptions

- Braced at midpoint
- No Bending

- Caused by Design error
 - Buckling (wrong unbraced length, soft braces)
 - Did not recognize bending

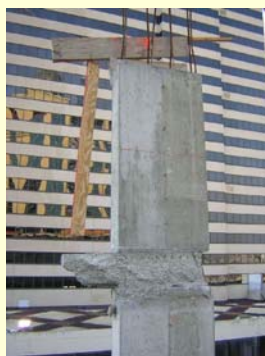
Slab-to-Column Connections

- Four employees of Concrete Contractor observed cracks on underside, along Column Line 1
 - Wide enough to insert a credit card
 - As much as 1/8" wide
 - Some thru entire slab thickness
- Some told supervisor
- Supervisor inspected. Thought that the cracks were minor. Took no action.

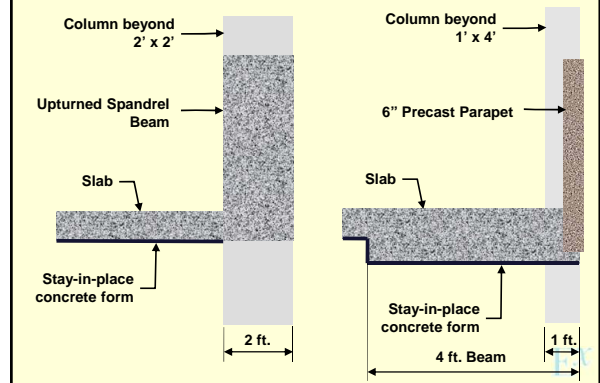
Spandrel--Before and After

- Beam bars shown next to column
- No section provided
- Top and bottom bars specified

- Precast engineer/supplier—Changed design
- Structural engineer— Did not require bars thru columns
- General Contractor—Did not coordinate subcontractors
- Concrete Contractor—Did not report slab cracking
- Rebar detailer-- Did not detail bars thru columns
- Rebar installer-- Did not place bars thru columns
- Rebar inspector— Did not question no bars thru columns
